Wildlife Survey & Photo Service

RE: LPCCC Meeting - February 9, 2017 - Salmon Monitoring

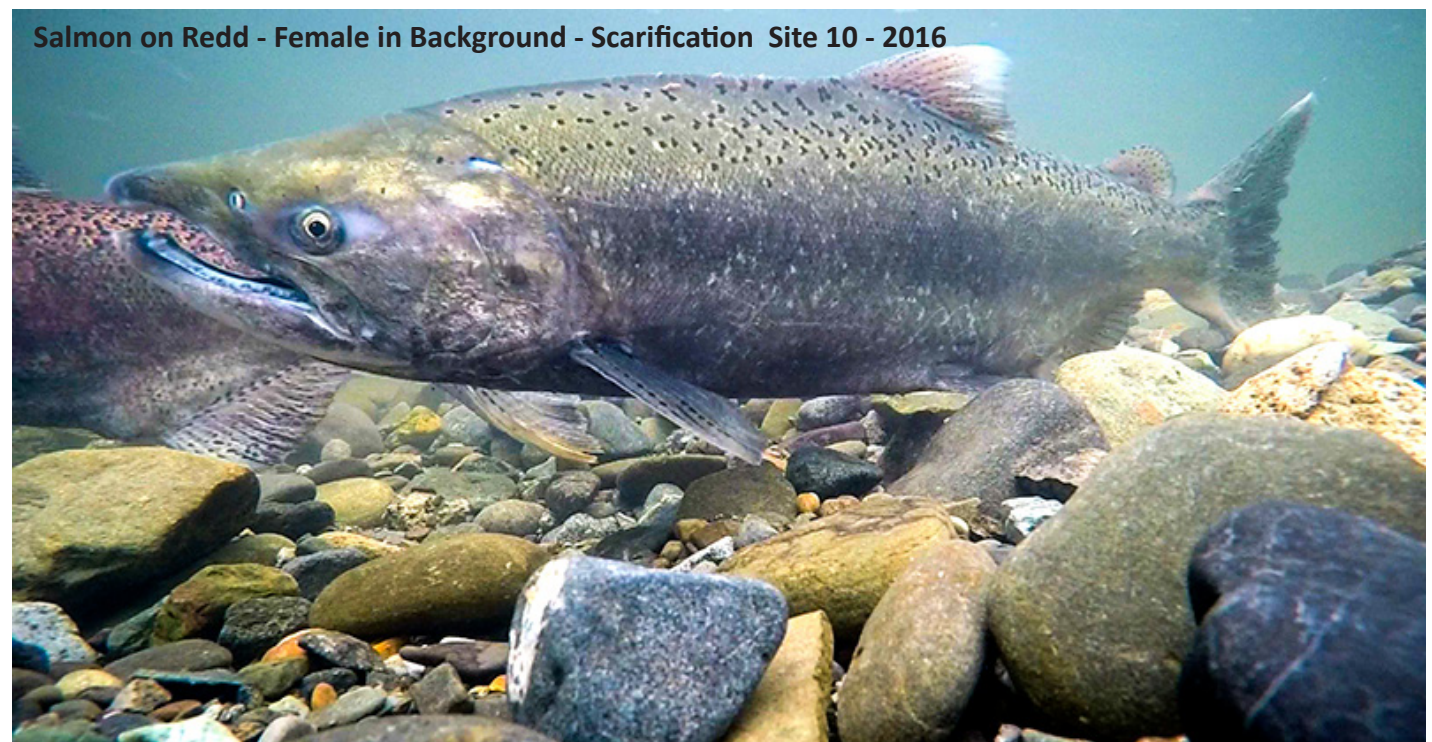
During the recent storm events, when conditions allowed, I looked at several of the Scarification Spawning sites. After the first flood event I looked at salmon redds on January 16th. The redds that were in areas with large enough cobble that allowed the female salmon to "armor" the upstream side of the redds looked fine. They were not significantly impacted by flood scour. Those areas were also in areas with sufficient flood plains to disperse the flows energy away from the main channel. The impact of the sediment is another matter.

I am working on the 2016 Spawning Scarification Report and will have that to you ASAP. Please note the image below taken at Scarification Site 10. The redd was well armored with larger cobble and eventually was deep enough to withstand significant flows.
