# Wildlife Survey & Photo Service

2040c\_Design Channel

October 16, 2006

**Subject: Putah Creek - Design Channel**

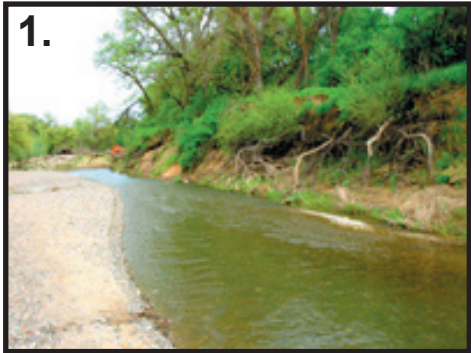
1. Part of the 1000- foot section of Putah Creek that was returned to its historical channel.

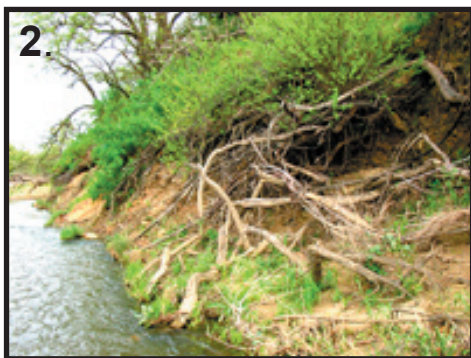
2. Closeup of the section of Putah Creek that was undermining Putah Creek Road.

Prior to 1997 a major bed of Giant Reed (*Arundo donax*) forced the low-flow channel to the south. The creek was rapidly eroding the bank near a walnut orchard and undermining Putah Creek Road. The Solano County Water Agency (SCWA) and the Lower Putah Creek Coordinating Committee (LPCCC) initiated a realignment project which was funded by the Urban Streams Program (DWR). The channel realignment was designed to reduce major erosion (picture #2), reduce the sediment load entering the creek, and restore the base of Putah Creek Road.

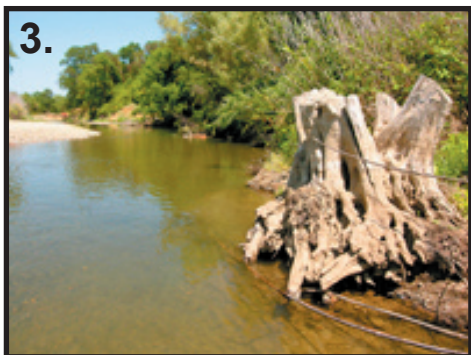
3. Slow water section of Putah Creek at the confluence of Dry Creek prior to realignment.

Prior to the channel realignment, invertebrates possibly entering Putah Creek from Dry Creek were subject to marginal habitats that would not support their environmental requirements (Picture #3). Another species - *Nixe criddlei* - whose numbers have dramatically increased since the realignment was found rarely in the out-of-place channel and sporadically in some downstream habitats. On 6/8/06 a significant population was discovered at the Kilkenny Weir, 3.5 miles downstream from the Design Channel. Seventy percent of the cobble surveyed at the Kilkenny site held mature *Nixe criddlei* nymphs (Acceptable habitat did not exist at the Kilkenny site until the weir construction in the fall of 2006). The occurrence of *Nixe* is somewhat predictable as their environmental requirements in Putah Creek are well defined.

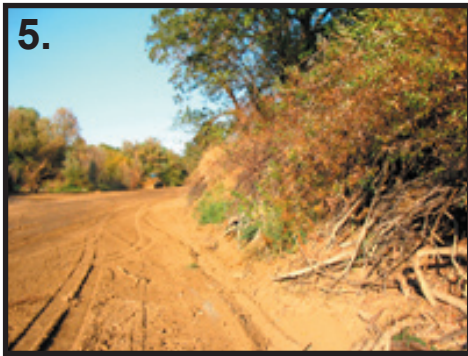
5. Out-of-place channel after fill and initial grading.

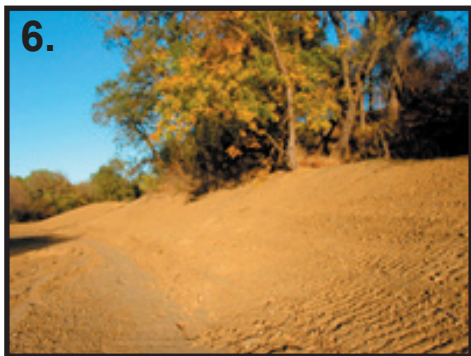
6. The out-of-place channel after fill and slope applied toward Putah Creek Road. Seeding was completed after this image was recorded.

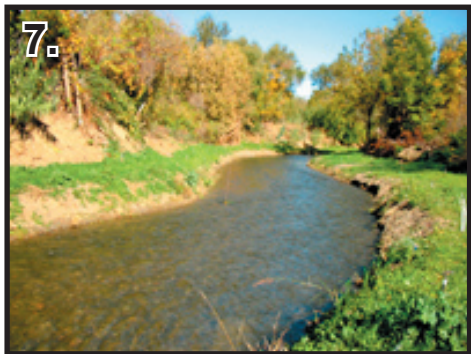
7. Design Channel after Putah Creek was returned to its historical channel. Image taken prior to high water events in early 2006.

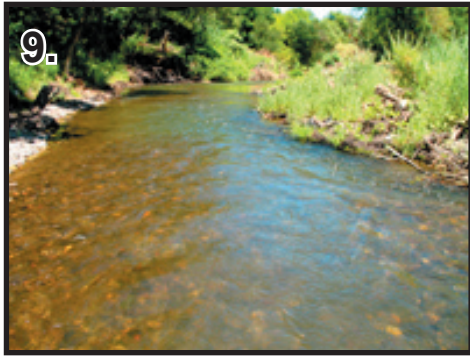
9. Design Channel on 7/12/06. Note willow growth on right bank.
